October 19, 2021

Project 171.06108.011

RE: Asbestos Conditions Assessment
Mason Station
Wiscasset, Maine

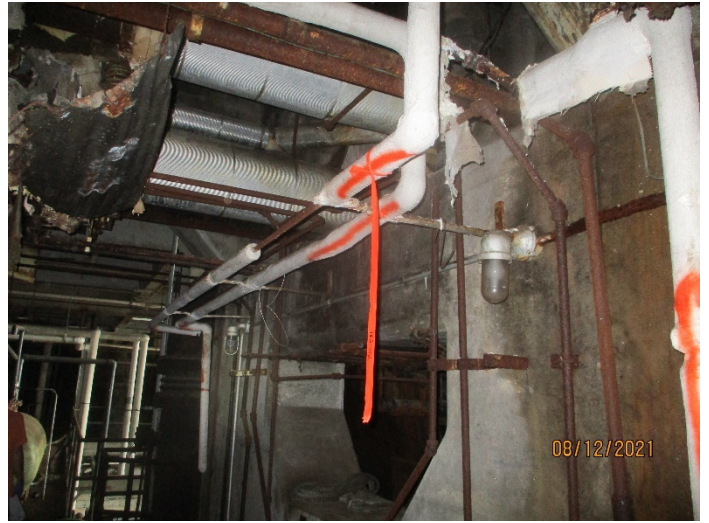
Photo 1&2-01: Non-ACM by analysis

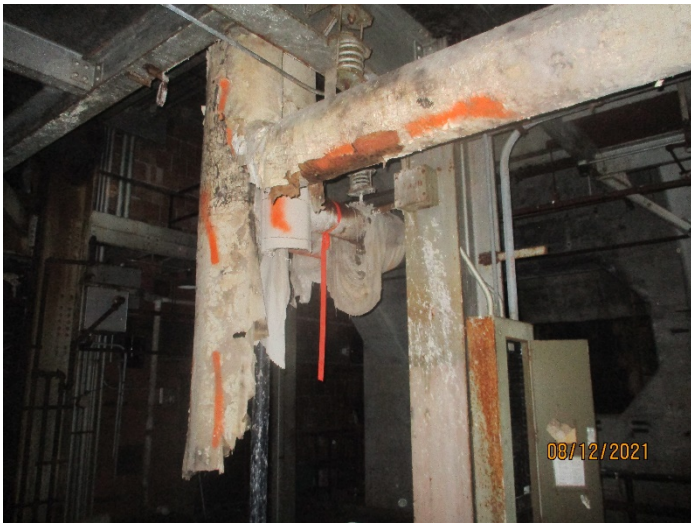
Photo 1&2-10/11: Non-ACM by Analysis

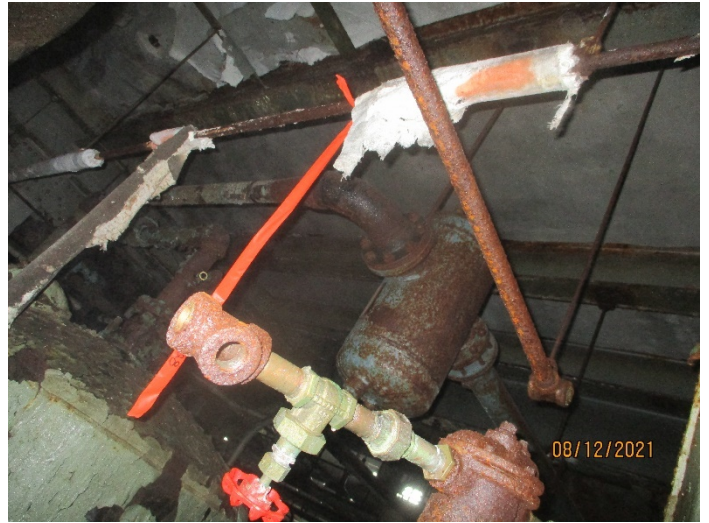
Photo 1&2-27: Non-ACM by Analysis

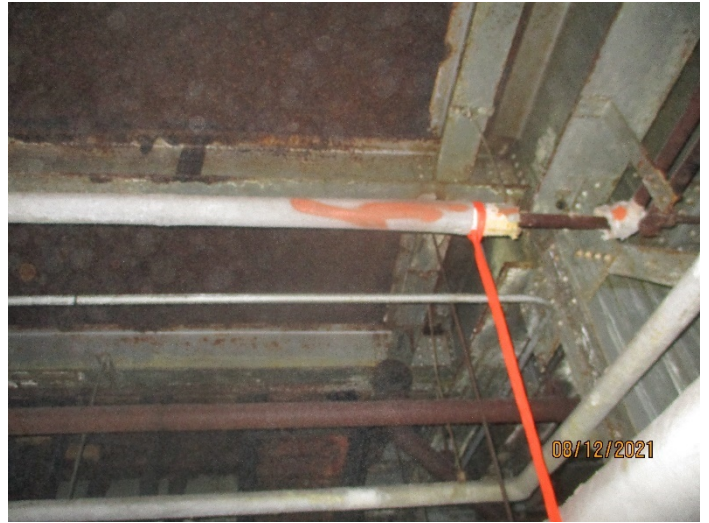
Photo 1&2-33: Non-ACM by Analysis

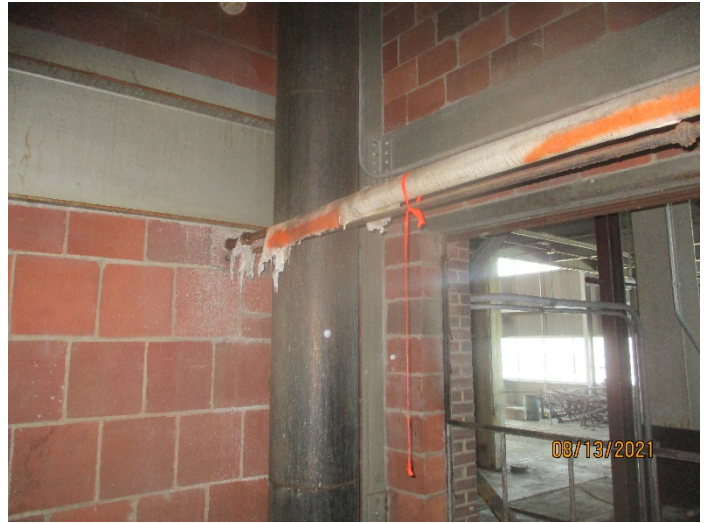
Photo 1&2-55: Non-ACM by Analysis
